TESTS OF EFFECTS OF LONG DURATION BLAST-TYPE FLOWS ON FIRES IN
INTERIORS (INCLUDING EOC'S)

INTERIM TESTS OF THE EFFECTS OF LONG DURATION BLAST-TYPE FLOWS ON FIRES IN URBAN INTERIORS AND ON THE CONTENTS OF EMERGENCY OPERATING CENTERS (EOC)

C. Wilton
R. Kaplan
SCIENTIFIC SERVICE, INC.
1536 Maple Street
Redwood City, California 94063

Contract No. DAHC20-73-C-0195
DCPA Work Unit 2563A
COTR - Dr. Michael A. Pachuta

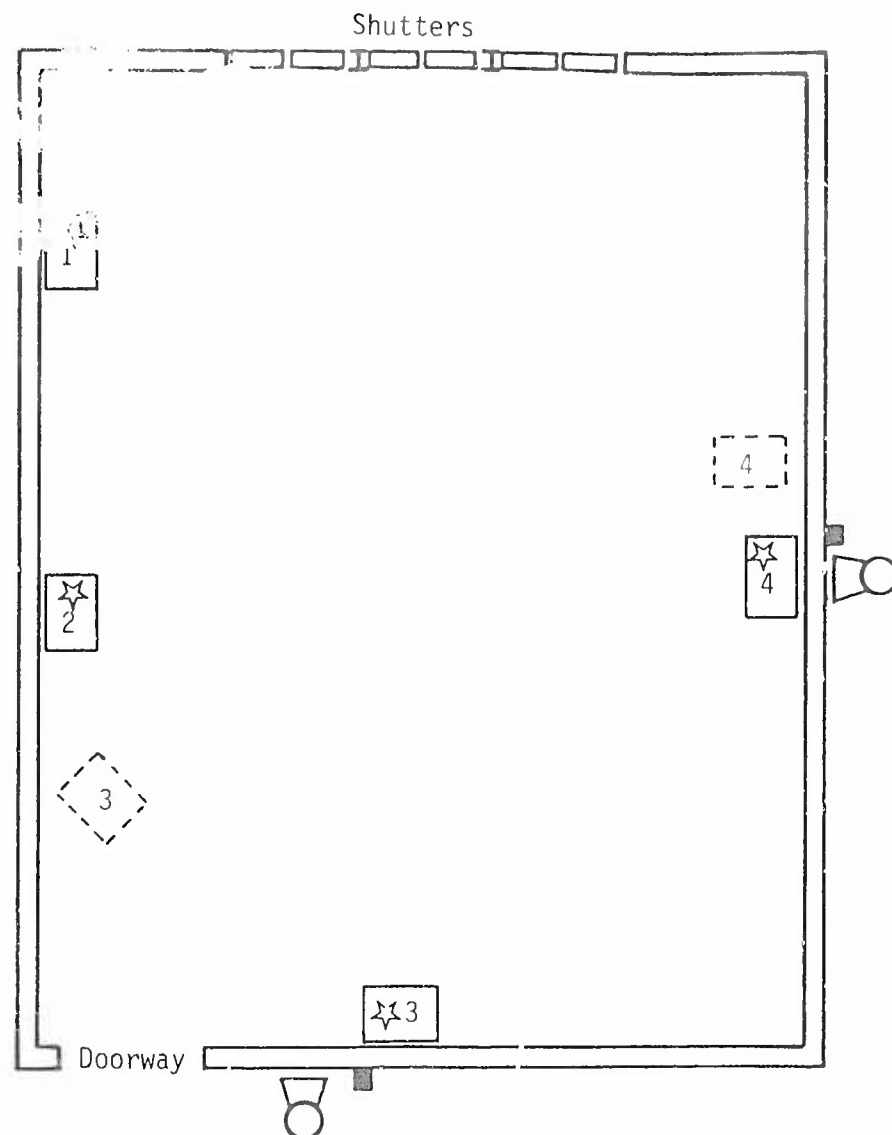
Fig. 19-1. Sketch of Test Geometry, Test Number 19

1, 2, 3, & 4 - 8.5 x 12.5 x 8 in. wire cages containing ignited paper. (Dotted lines indicate posttest locations)

☆ Ignition sources

After the shot the contents of cages 1 and 2 were found totally consumed; the fires were extinguished in cages 3 and 4, which were displaced as shown in Fig. 19-1. This suggests that cages 1 and 2 were away from the direct high velocity flow between the window and the doorway, that

cage 3 experienced a strong flow directly from the window, and that cage 4 was located in an area in which a high velocity swirl formed. Posttest photographs are shown in Figs. 19-3 through 19-5.

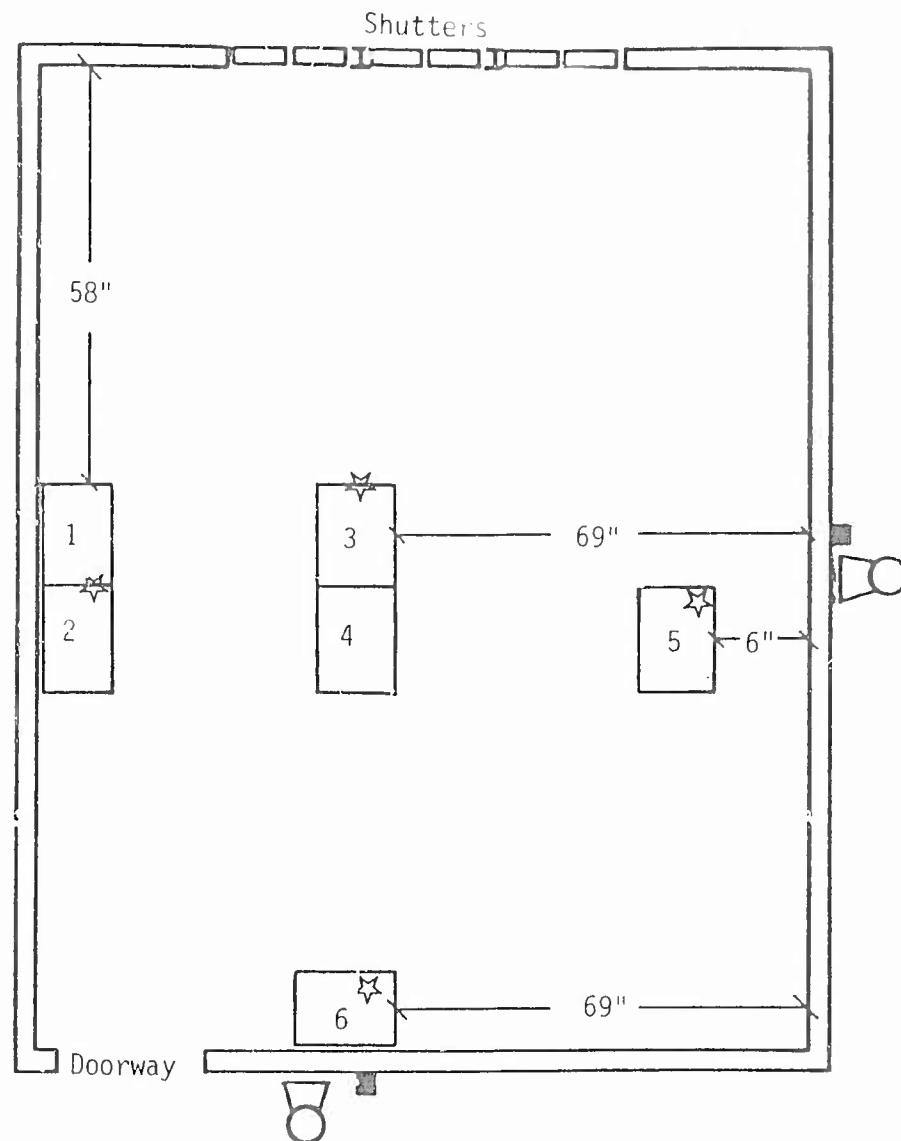
Fig. 20-1. Sketch of Test Geometry, Test Number 20

- 1, 2, 5, & 6 - 17 x 13 x 13 in. cardboard boxes (weighted, no paper)
- 3 - 17 x 13 x 13 in. cardboard boxes stacked three high (full of paper)
- 4 - 17 x 13 x 13 in. cardboard boxes stacked three high (top box full of paper)
- ☆ Ignition sources

This simulated warehouse room was arranged very much like that of Test 18, with a central stack of 6 boxes containing a good deal of paper, and four weighted but empty boxes placed in various other parts of the room. See Fig. 20-1 and the photographs of Figs. 20-2 through 20-4.

For the first time, all flames were extinguished and none rekindled. More movement of the weighted boxes was evident than before. Those along the side wall nearest the doorway were moved away from the wall and toward the front wall. The one along the opposite side wall moved upstream some 10 ft, coming to rest against one of the shutter openings, suggesting the presence of a strong eddy. Posttest photographs are shown in Figs. 20-4 through 20-7.

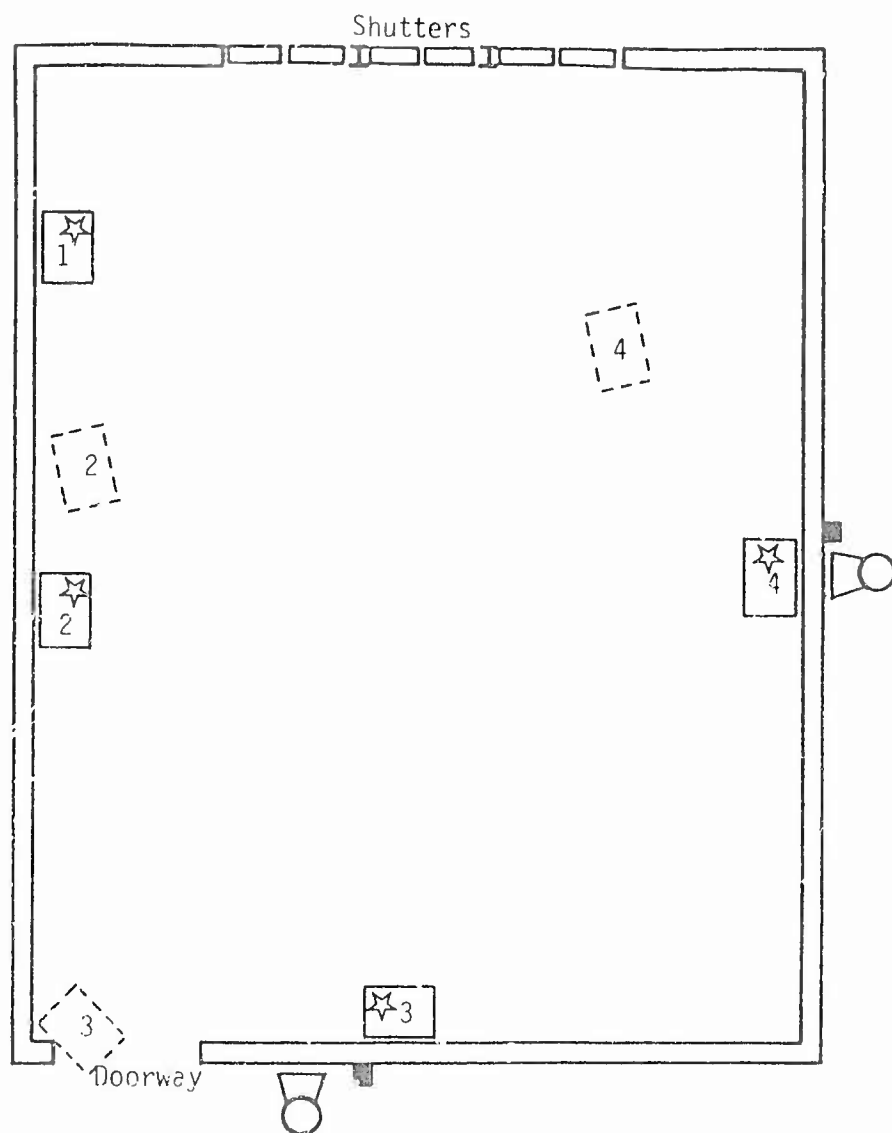
Fig. 21-1. Sketch of Test Geometry, Test Number 21

1, 2, 3, & 4 - 8.5 x 12.5 x 8 in. wire cages containing paper
(dotted lines indicate posttest locations)

☆ Ignition sources

As with Test 19, this was solely a confined fuel test, with paper fuel in four cages at various places in the room. (See Figs. 21-1 through 21-3. The overpressure used in this test was, however, much higher than that of Test 19 (5.5 psi chamber pressure vs. 2 psi).

The results of the test were similar to those of Test 19 except that more fires were extinguished. Only fuel in cage number 1 continued to burn. Fires in the other three were extinguished and the cages themselves were translated as shown in Fig. 21-1. These translations give some insight into the flow field that established itself in the room.
